DEPARTMENT OF TRANSPORTATION**DIVISION OF ENGINEERING SERVICES**

Contract #: 04-0120F4Cty: SF/ALA Rte: 80 PM: 13.2/13.9File #: 1.28**WELDING INSPECTION REPORT****Resident Engineer:** Casey, William**Address:** 333 Burma Road**City:** Oakland, CA 94607**Report No:** WIR-028829**Date Inspected:** 21-Nov-2012**Project Name:** SAS Superstructure**OSM Arrival Time:** 700**Prime Contractor:** American Bridge/Fluor Enterprises, a JV**OSM Departure Time:** 1530**Contractor:** American Bridge/Fluor Enterprises, a JV**Location:** Job Site

CWI Name:	Bernie Docena and William Sherwood			CWI Present:	Yes	No
Inspected CWI report:	Yes	No	N/A	Rod Oven in Use:	Yes	No N/A
Electrode to specification:	Yes	No	N/A	Weld Procedures Followed:	Yes	No N/A
Qualified Welders:	Yes	No	N/A	Verified Joint Fit-up:	Yes	No N/A
Approved Drawings:	Yes	No	N/A	Approved WPS:	Yes	No N/A
				Delayed / Cancelled:	Yes	No N/A
Bridge No:	34-0006			Component:	SAS OBG

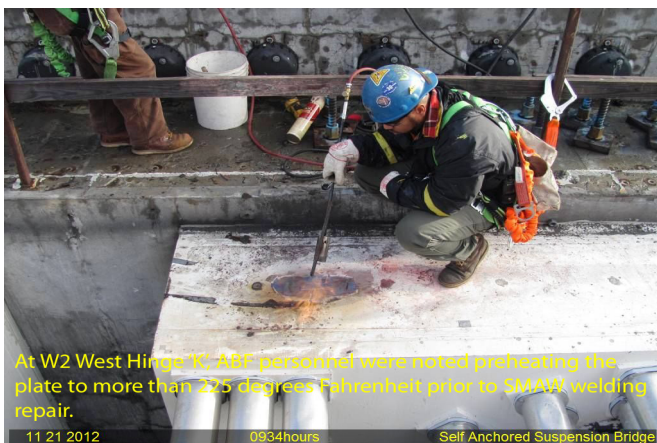
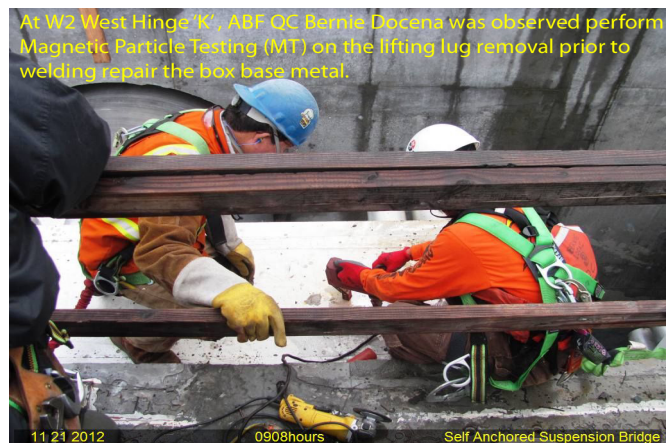
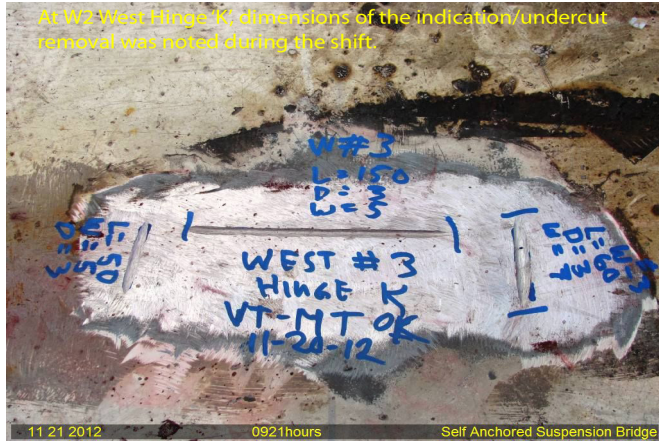
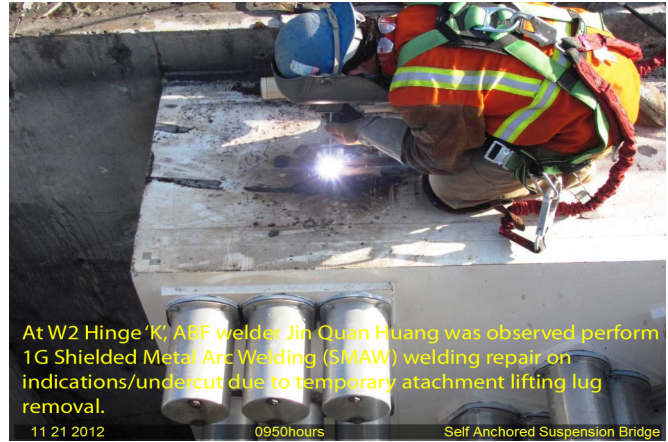
At W2 Hinge 'K' West bound, QA randomly observed ABF/JV welder Jin Quan Huang perform ASTM A709 Grade 485W base metal repair on the Hinge 'K' box due to undercut that was previously welded on lifting lug temporary attachment. This base metal repair is being welded per Caltrans approved Request for Weld Repair (RWR) # 201211-033 dated November 14, 2012. The welder was noted welding in 1G (flat) position utilizing Shielded Metal Arc Welding (SMAW) with 3.2mm diameter E9018H4R electrode implementing Caltrans welding procedure ABF-WPS-D15-1002 Repair. The welder was also noted performing the base metal repair at Lift Lug # 1 and 3. Prior welding, the welder excavated the lifting lug temporary attachment removal undercut/indications using a disc grinder. ABF QC Bernie Docena was noted on site verifying the complete removal of the undercut/indications using Magnetic Particle Testing (MT). After the removal and MT verification from ABF QC, this QA performed the same test (MT) and noted same result.

The welder preheated the A709 Grade 485W base plate to 225°F using propylene gas torch. After attaining the required preheat and verification from ABF QC, the welder started SMAW welding the base metal repair. During the shift, the welder has completed the repair at West Hinge 'K' Lift Lug # 1 and 3.

At OBG 12E-E2.1-C corner drop-in side plate inside, QA randomly observed ABF/JV welder Mike Jimenez continuing to perform CJP groove welding repair at various Y locations. The repair welding is being performed as a continuation from the repair that were made from outside per Caltrans approved Request for Weld Repair (RWR) #201210-013. The welder was observed manually welding in the 1G (flat) position utilizing Shielded Metal Arc Welding (SMAW) with 4.0mm diameter E7018H4R electrode implementing Caltrans welding procedure ABF-WPS-D15-1004 Repair. The second time repair excavation was preheated to more than 225 degree Fahrenheit using Miller Proheat 35 Induction Heating System with the heater blanket put in place on top of the side plate prior excavation. During the shift, ABF QC William Sherwood was noted monitoring the welder with measured working current of 130 amperes on the 3.2mm E7018H4R electrode and adjusted preheat temperature of 325°F during welding. During the shift, the welder has not completed the welding repair mentioned above but performed the Post Weld Heat Treatment (PWHT) of 450°F and held it for one (1) hour after welding as required. The locations and dimensions of the repair excavations are as follows; 1. Y=12650mm, L190mm, W25mm, D11mm, RWR#201210-013, R2- in progress. 2. Y=12500mm, L100mm, W20mm, D10mm, RWR# 201210-013, R2- in progress. 3. Y=13510mm, L100mm, W20mm, D9mm, RWR# 201210-013, R2- excavated. 4. Y=13680mm, L100mm, W22mm, D13mm, RWR #201210-013, R2- excavated. 5. Y=13830mm, L65mm, W20mm, D4mm, RWR #201210-013, R2- excavated.

At OBG 12W-W2.1-C1.1 corner drop-in side plate outside, QA randomly observed ABF/JV welder Ric Chouinard perform CJP groove welding repair at various Y locations. The repair welding is being performed per Caltrans approved Request for Weld Repair (RWR) #201211-005. The welder was observed manually welding in the 4G (overhead) position utilizing Shielded Metal Arc Welding (SMAW) with 4.0mm diameter E7018H4R electrode implementing Caltrans welding procedure ABF-WPS-D15-1004 Repair. The first time repair excavation was preheated to more than 225 degree Fahrenheit using Miller Proheat 35 Induction Heating System with the heater blanket put in place on top of the side plate prior excavation. During the shift, ABF QC Salvador Merino was noted monitoring the welder with measured working current of 126 amperes on the 3.2mm E7018H4R electrode and adjusted preheat temperature of 325°F during welding. During the shift, the welder has not completed the welding repair mentioned above but performed the Post Weld Heat Treatment (PWHT) of 450°F and held it for one (1) hour after welding as required. The locations and dimensions of the repair excavations are as follows; 1. Y=30850mm, L270mm, W50mm, D10mm, RWR #201211-005, R1- in progress. 2. Y=29800mm, L100mm, W55mm, D10mm, RWR #201211-005, R1- in progress. 3. Y=30000mm, L660mm, W55mm, D10mm, RWR #201211-005, R1- excavated.
